**Adapting a Riverine
Litter Indicator for
OSPAR Monitoring: A
Framework for
Norwegian Conditions
M-3080|2025.**

SALT RAPPORT 1098

Miljødirektoratet/ Norwegian Environment Agency

Marte Haave (SALT) and Gaute Velle (NORCE)

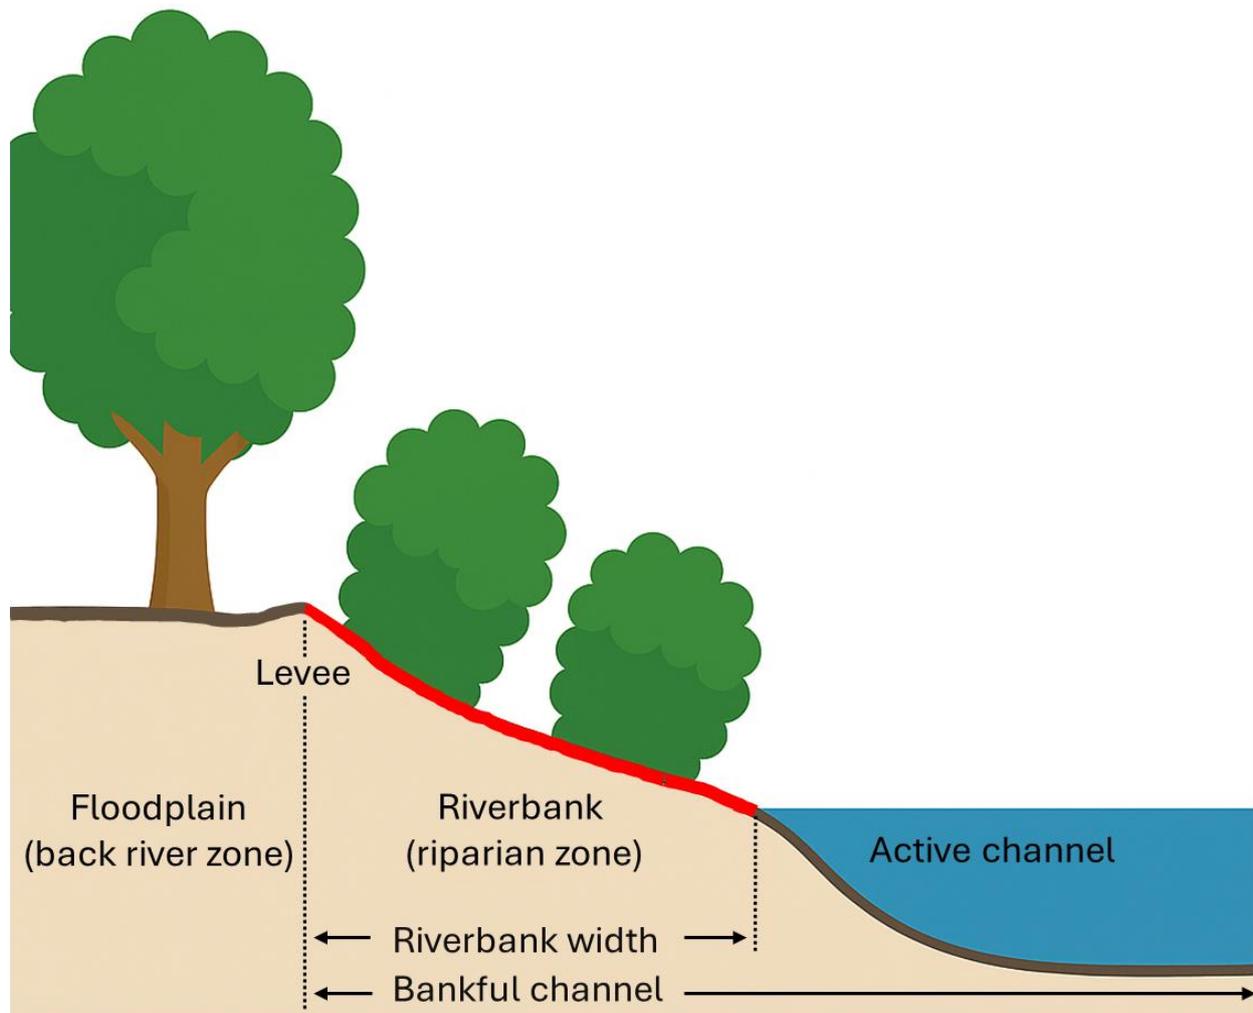
Figure 2: Schematic cross-section of a riverbank and channel, with terminology used trough the report.

This part is a translation of the CEMP guidelines for beach litter monitoring to river conditions. In the same way as the CEMP guidelines, the riverine litter monitoring form (Appendix 1) is meant to map and describe the most important properties of the river, surveillance area and surroundings, to help classify and interpret the future monitoring data. This form is to be filled out once per site but may be amended if the conditions change substantially and revisions are considered necessary. The list presents a suggestion of conditions and elements that may influence the amount of litter and the likelihood of litter accumulation on the riverbanks.

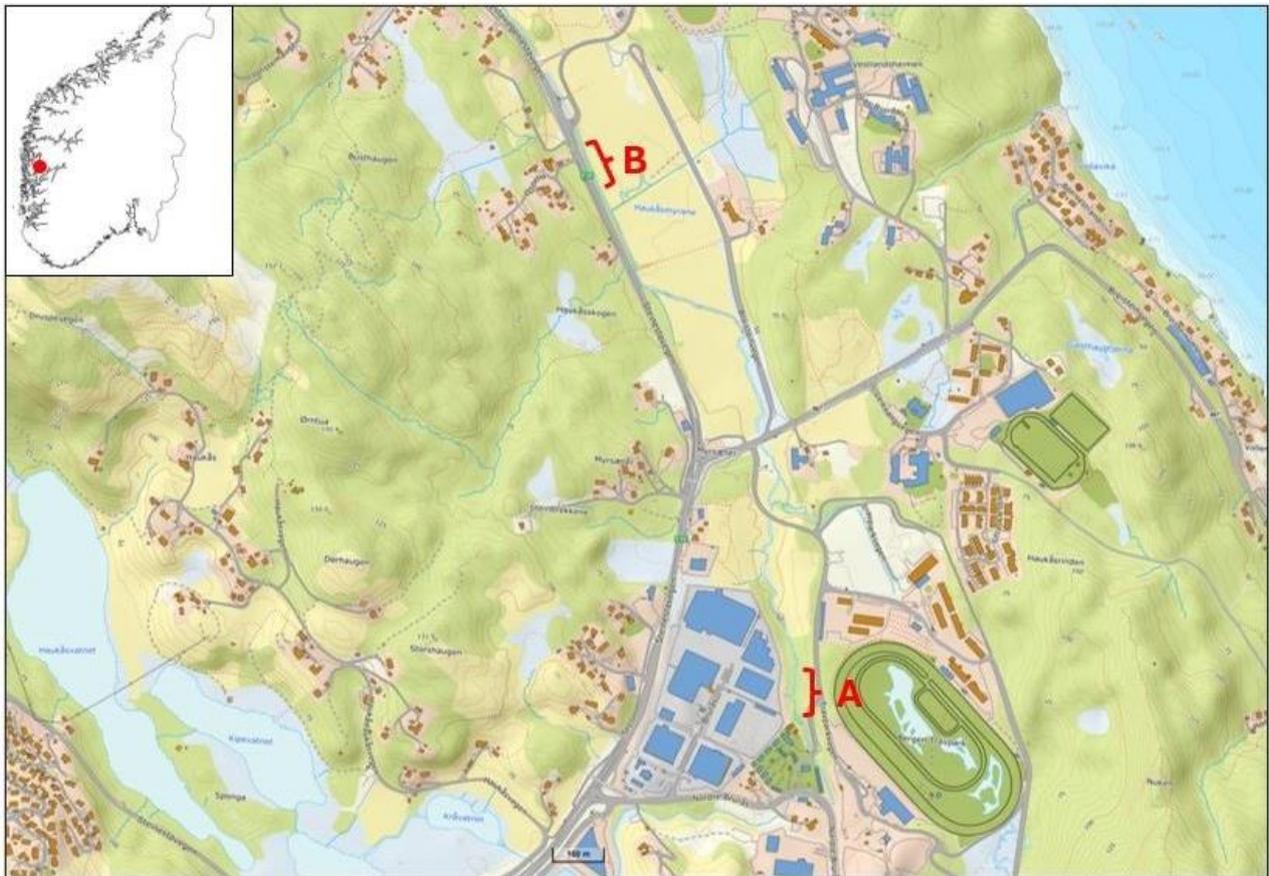
Figure 3: Map over the Haukås river with segment A and B (top).

The segment Haukås B is downstream from Haukås A (Figure 3). At segment B, the river runs between the motorway and farmland. The previously plastic polluted area had been cleaned some time before the survey in May, and there was hardly any litter to be found. The riverbank is in part supported by boulders (riprat) as bank-protection walls, and the riverbank is steep, straight and

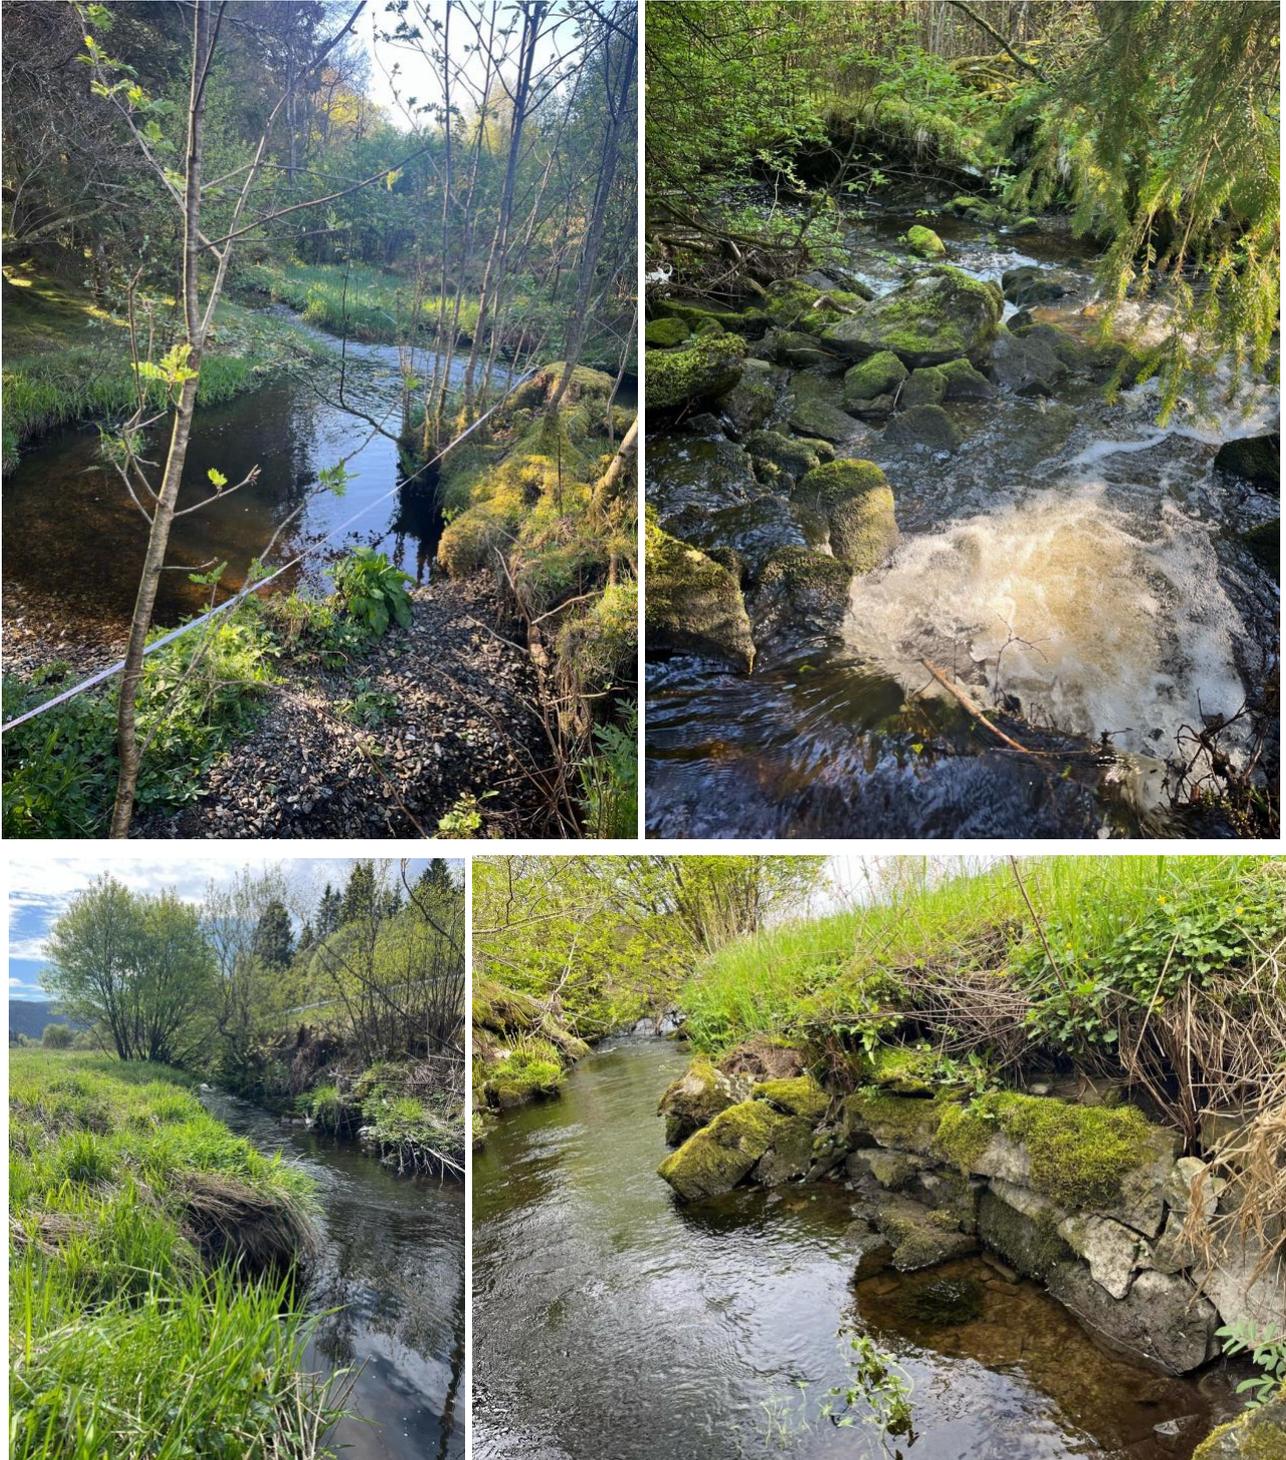
Figure 4: Images from Haukås segment A (top), showing variation in the riverbank and vegetation properties. Segment B (bottom) where the riverbank is steep and supported by boulders (riprat). Images from the fieldwork in May 2025.

Despite the densely vegetated and erratic riverbank, our observation is also that Haukås A will trap and collect litter. Finding litter items in such conditions may be challenging, especially when the foliage is fully developed, and the surveys must take the necessary time to search for all items. However, if monitoring is carried out before foliage and vegetation develops, we believe this segment could be suitable for monitoring under OSPAR.

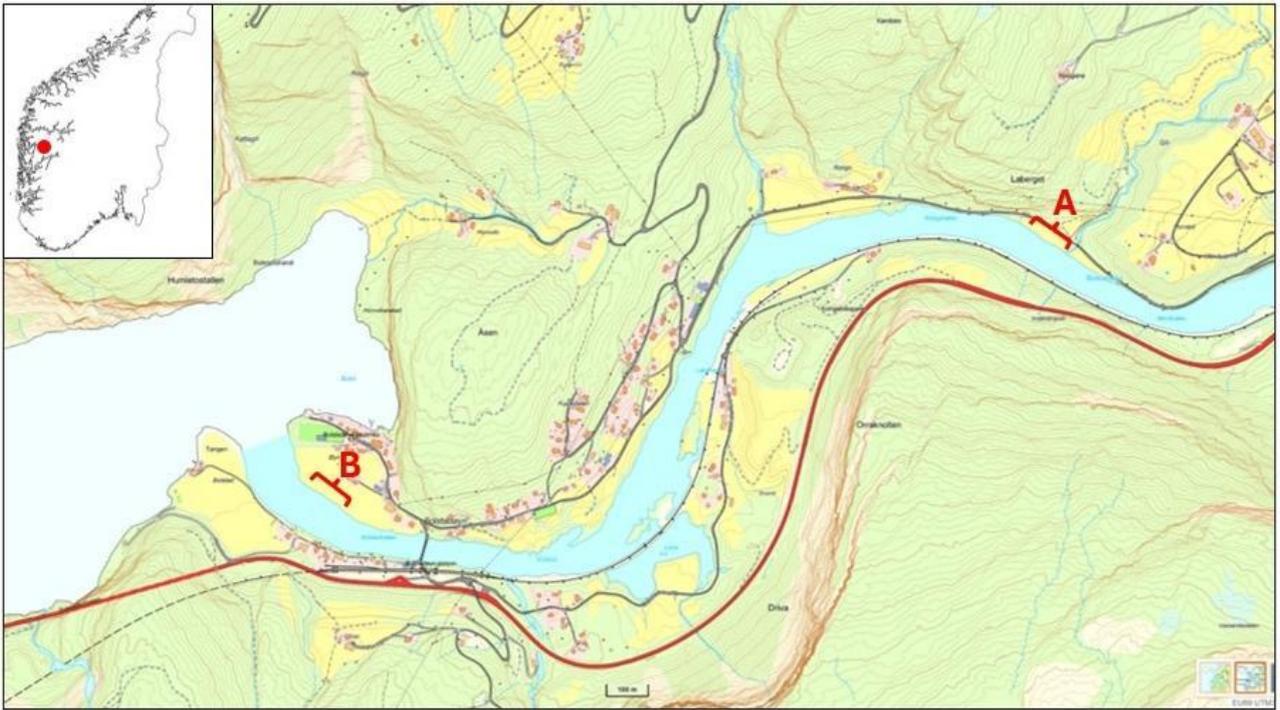
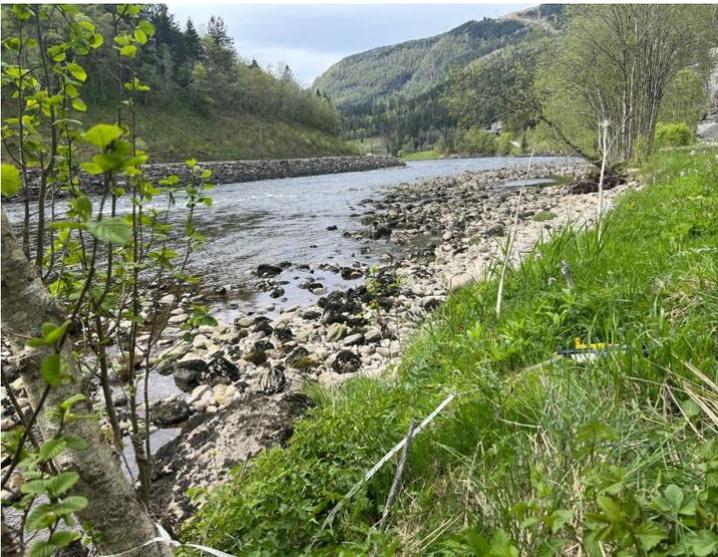
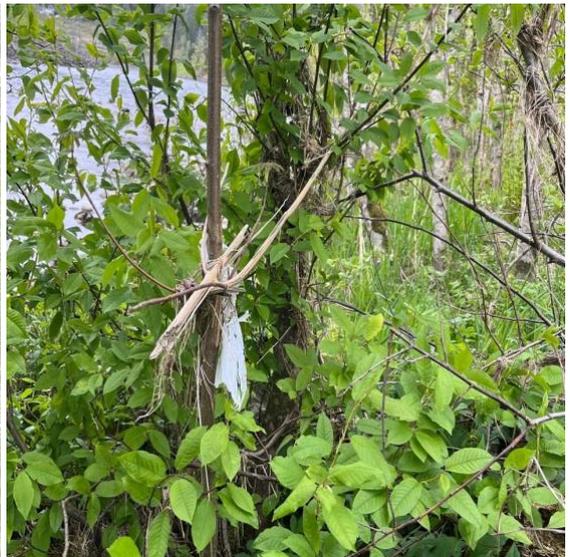
Figure 5: Map of Bolstad river in the Vosso catchment showing segment A and B (top), and photos from Bolstad segment A during the fieldwork in May 2025

During the survey in May the river flow habitat type was described as riffle and rapid. Bolstad A had few litter items. It was easy to walk along, and the litter was visible despite the somewhat developed vegetation along the low brink, which could overflow during spring floods (Figure 5, bottom). Indications of the higher water level during the spring flood was evident in the shrubbery near the river as grass and litter in the trees (Figure 5, bottom), The farmland alongside the river had likely been cleaned since the last flood, perhaps during grass cutting. The vegetation along the riverbank was searched thoroughly for litter, and a few items, for example agricultural plastics, were found stuck in the branches and between the herbs on the ground (Figure 5, bottom right). Apart from this, litter did not seem to accumulate along the riverbank in Bolstad A, or there is very little litter in the river. Low accumulation rates were confirmed during the revisit to Bolstad in early November, when there were zero new items of litter. Segment A is therefore considered unsuitable for monitoring.

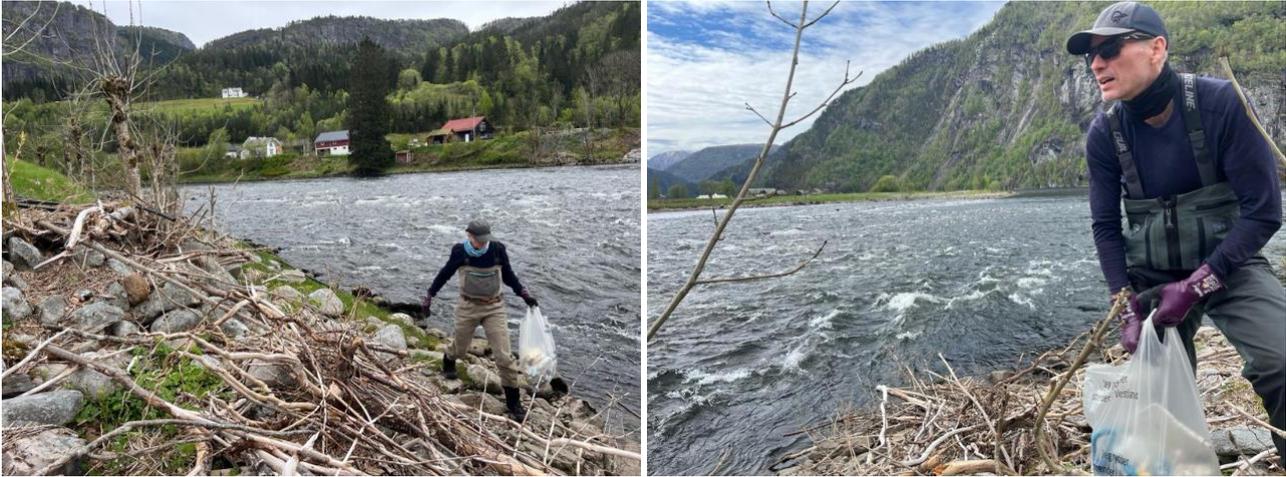
Figure 6: Photos from the riverbank at Bolstad segment B close to the river mouth, during the fieldwork in May 2025

Bolstad B was placed downstream of segment A, in an area with good access to the riverbank, and about 100 m upstream of the river mouth to prevent registering marine litter that could have entered the river at high tide (Figure 6, right). Bolstad River segment B was also easy to walk and relatively easy to observe and collect the litter from the rocky riverbank. There were no overhanging vegetation or large obstacles. In Bolstad B there was a high number of litter from a variety of sources, such as building/construction, agriculture, personal use and hygiene products that indicated how litter from several origins had been deposited at this site. The items of expanded polystyrene and Litex-bathroom wall plates were small, indicating that the items were not recently deposited, or that they may have travelled far and had been exposed to high mechanical force before deposition on the riverbank. Accumulation of organic riverine debris marked the flood line along the riverbank clearly, where the majority of the small litter items were found. The riverbank was high, and overflow would require a high flood. In May we observed 679 items and 3.9 kg of litter in this segment (Table 2). With the varied sources of litter, the clear signs of accumulation, the good overview and access to the riverbank we consider Bolstad B a typically suitable area for monitoring (Table 2, Figure 19, Appendix 2).

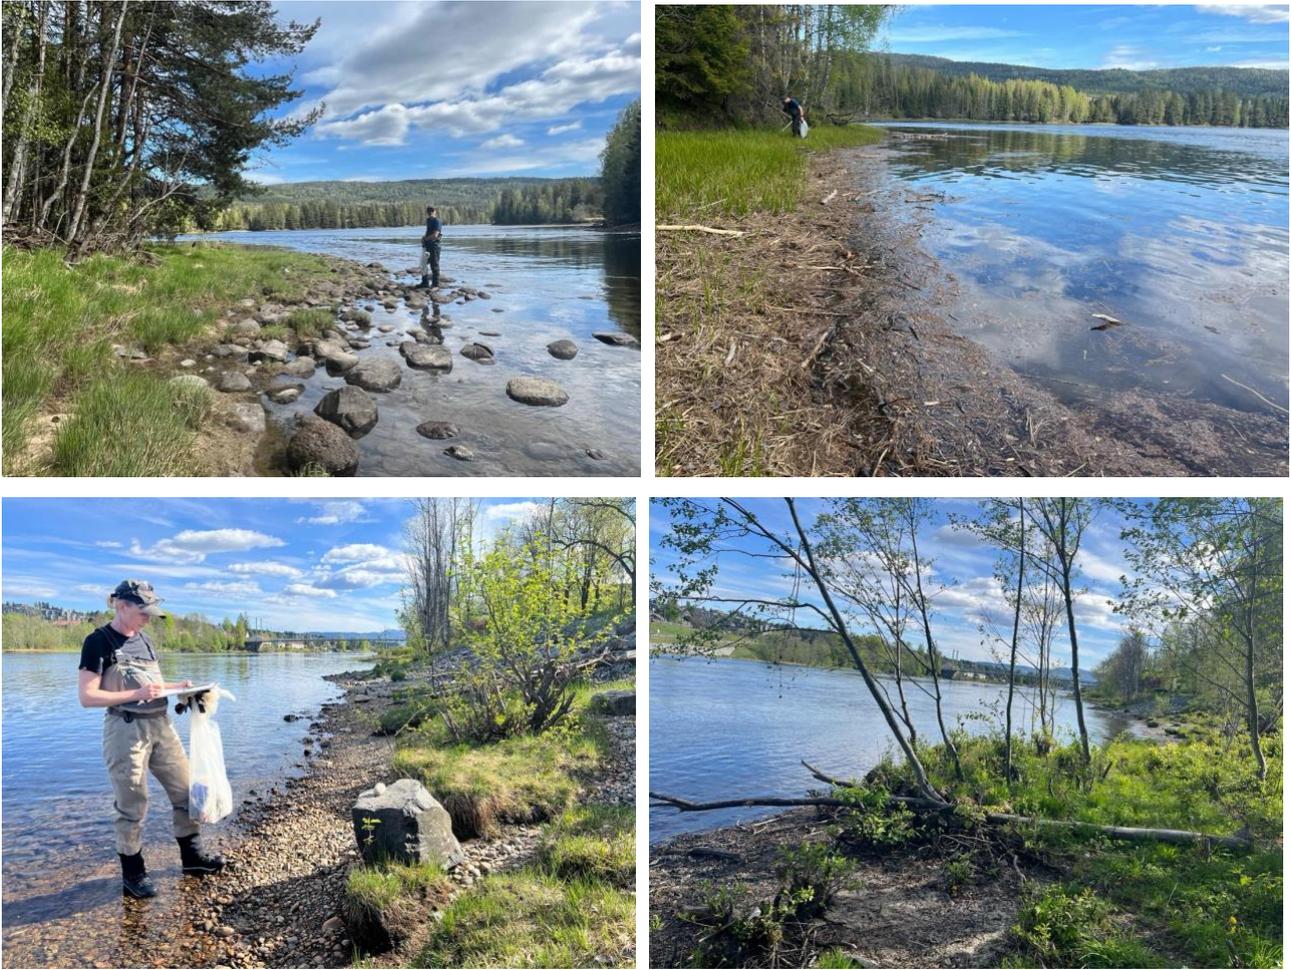
Figure 8: Map of Numedalslågen with segment A near the settlement Lampeland (top) and segment B (bottom) near the city of Kongsberg.

Numedalslågen River segment B (Figure 8, bottom) was in the city of Kongsberg. The nearest power station is Pikerfoss power plant, about 8 km upstream. The segment was easily accessible and easy to walk and clean, and with a discharge of about 50 m³/sec. The pebbles and short grass and the few trees along the riverbank were not seen as obstructions, despite the vegetation being quite developed at the time of the survey. The segment was in the vicinity of a museum, and we observed families playing by the water near the monitoring area during the survey. The museum park by the river was also well maintained and the grass had recently been trimmed. It is likely that such locations will be cleaned by by-passers or the museum wards. Both littering and removal of litter is likely to occur inside the segment. For that reason, we do not recommend setting up monitoring areas close to parks and recreational areas, corresponding to avoiding popular beaches in beach-litter monitoring.

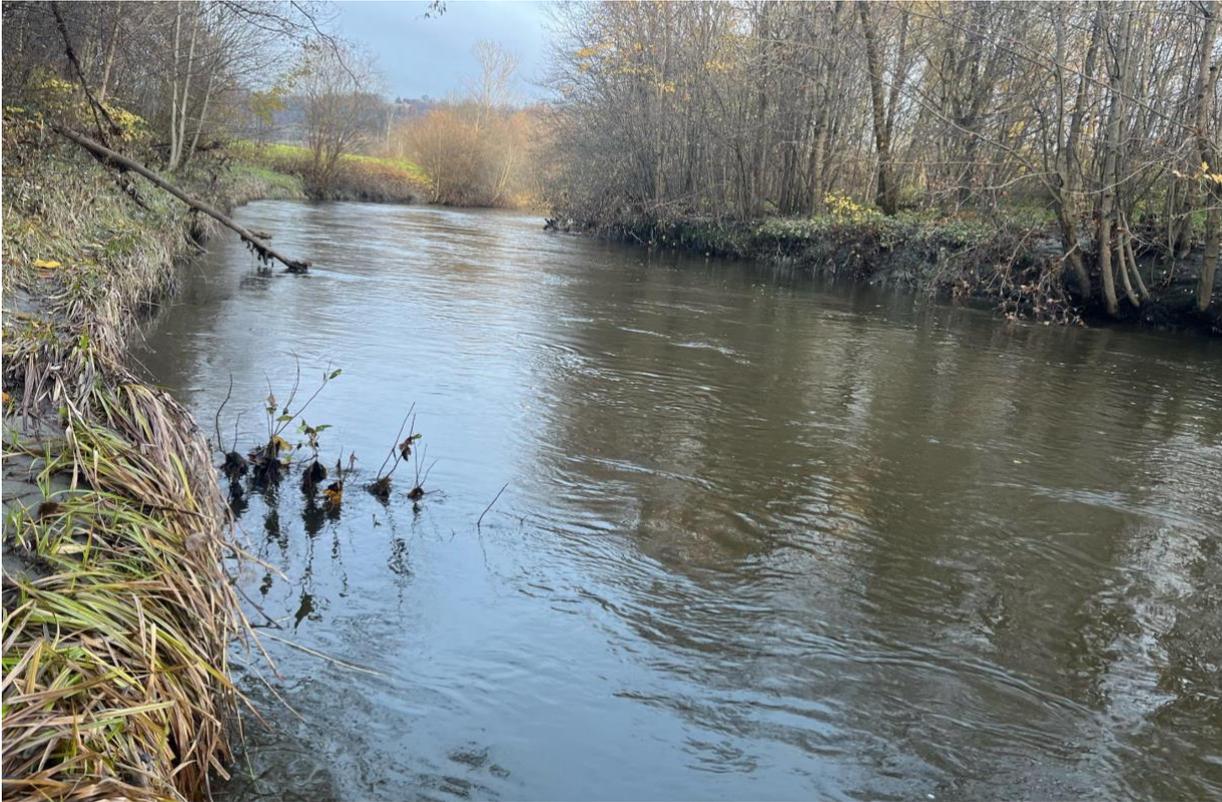
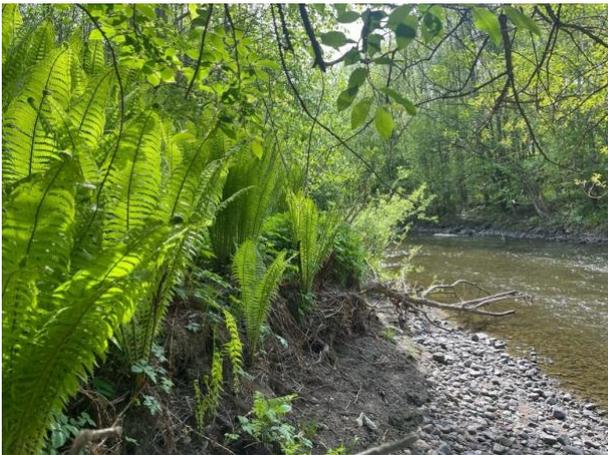
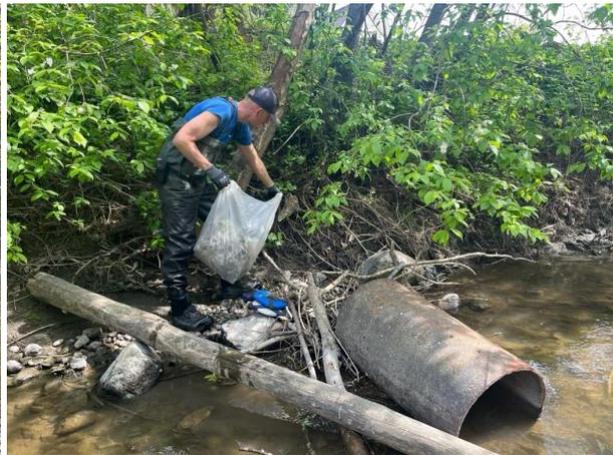
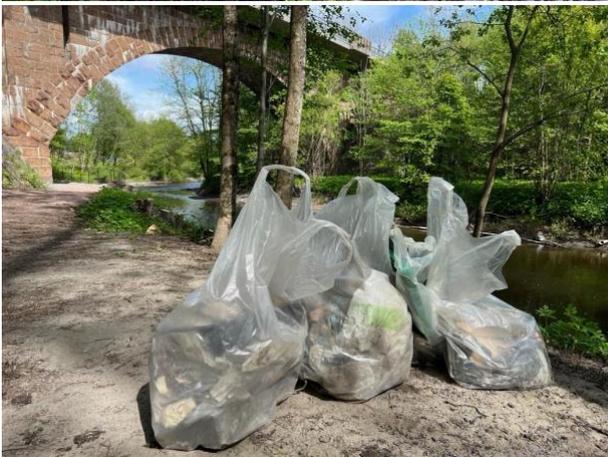
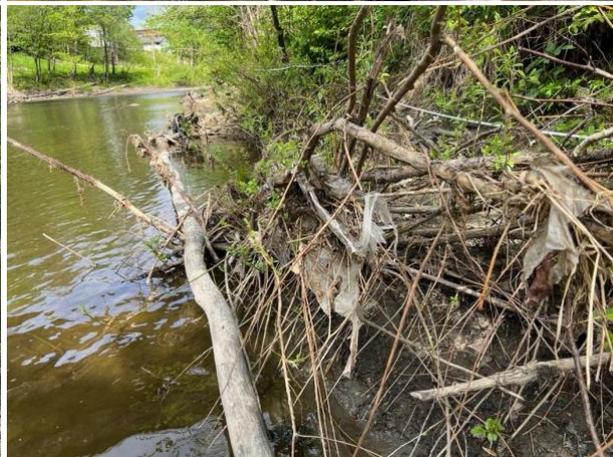
Figure10: Segment A in October when the discharge was higher than in May (top). Segment B (middle and bottom). Large items that cannot be removed must be noted in the registration form (middle right). A cleaning - event took place at the day of the survey in May (bottom left), litter still present within the river system on the day of the cleanup (bottom right).

In Lier segment A (Figure 9, Figure 10) the vegetation was quite developed, which to some extent obstructed visibility and cleaning. The riverbed and steep riverbank were sandy or muddy, and the water was not easily accessible from the riverbank. Therefore, the segment was only cleaned and monitored on land. Signs of a recent flood line was visible among the trees well above the water. In October the discharge was higher than in May (about 7.5 m³/sec at Opsal). A recent flood event (85 m³/sec at Opsal) had removed a lot of vegetation at the riverbank. Some litter was visible in the trees but had not accumulated on the ground.

Due to the steep and sandy riverbank with a drop to the water, we do not believe the segment to accumulate litter except at floods, and do not recommend Lier segment A for monitoring purposes.

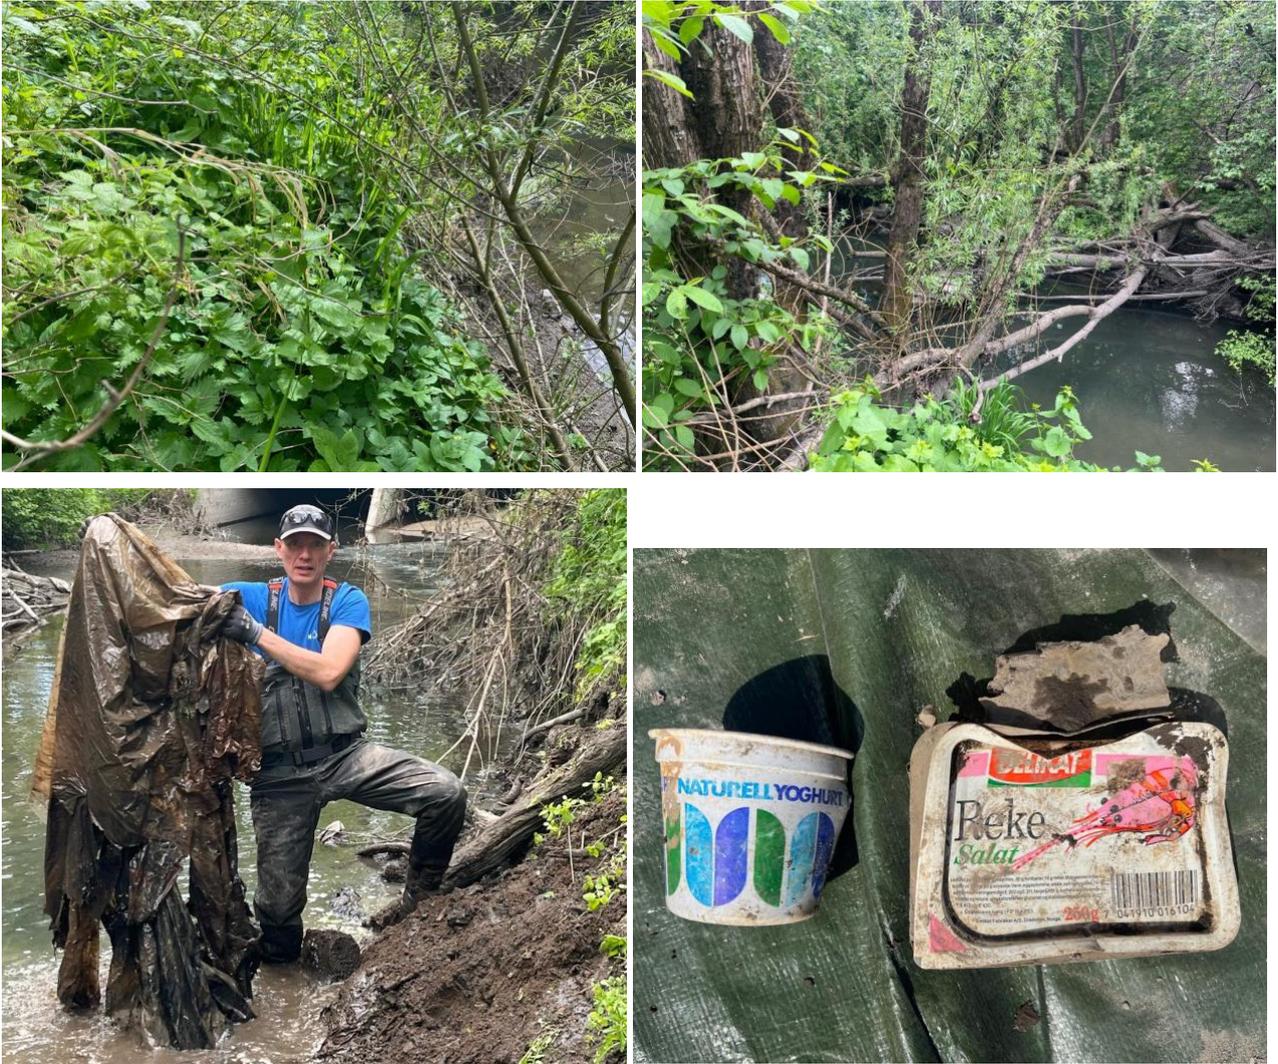
Figure 12: Photos of Alna A at the time of the survey showing the dense vegetation on the banks(top) and examples of old litter buried in the riverbank, indicative of an old dumpsite along the river (bottom). The recognizable design places this food packaging in the 1980's (bottom right).

At the date of the survey, Alna segment A had a moderate to low discharge dominated by glide. The vegetation was highly developed, which made it difficult to observe litter on the ground (Figure 12). Less than 100 metres from the culvert it was also difficult to pass the trees closest to the riverbank, and therefore to clean and monitor litter along the entire length of the segment (Figure 12, top). There have been several cleanup initiatives in the Alna River following the mapping of plastic in Norwegian rivers in 2024 (Velle et al. 2024). The position, amount and age of litter in segment A indicate, however, that this segment has not been cleaned recently.

Past events of sewage overflow were evident from several sanitary waste items on the riverbank. Sewage overflow and fertilization is also highly likely to have contributed to the dense vegetation at Alna A. The soft soil on the riverbank slopes and overhanging vegetation (Figure 12, top) made this area particularly difficult to walk along for monitoring, and there was a danger of sliding into the river. At a higher discharge, it will be difficult to access the water. The presence of a dumpsite, as well as the dense vegetation and steep slopes makes Alna A not recommended as a monitoring site.

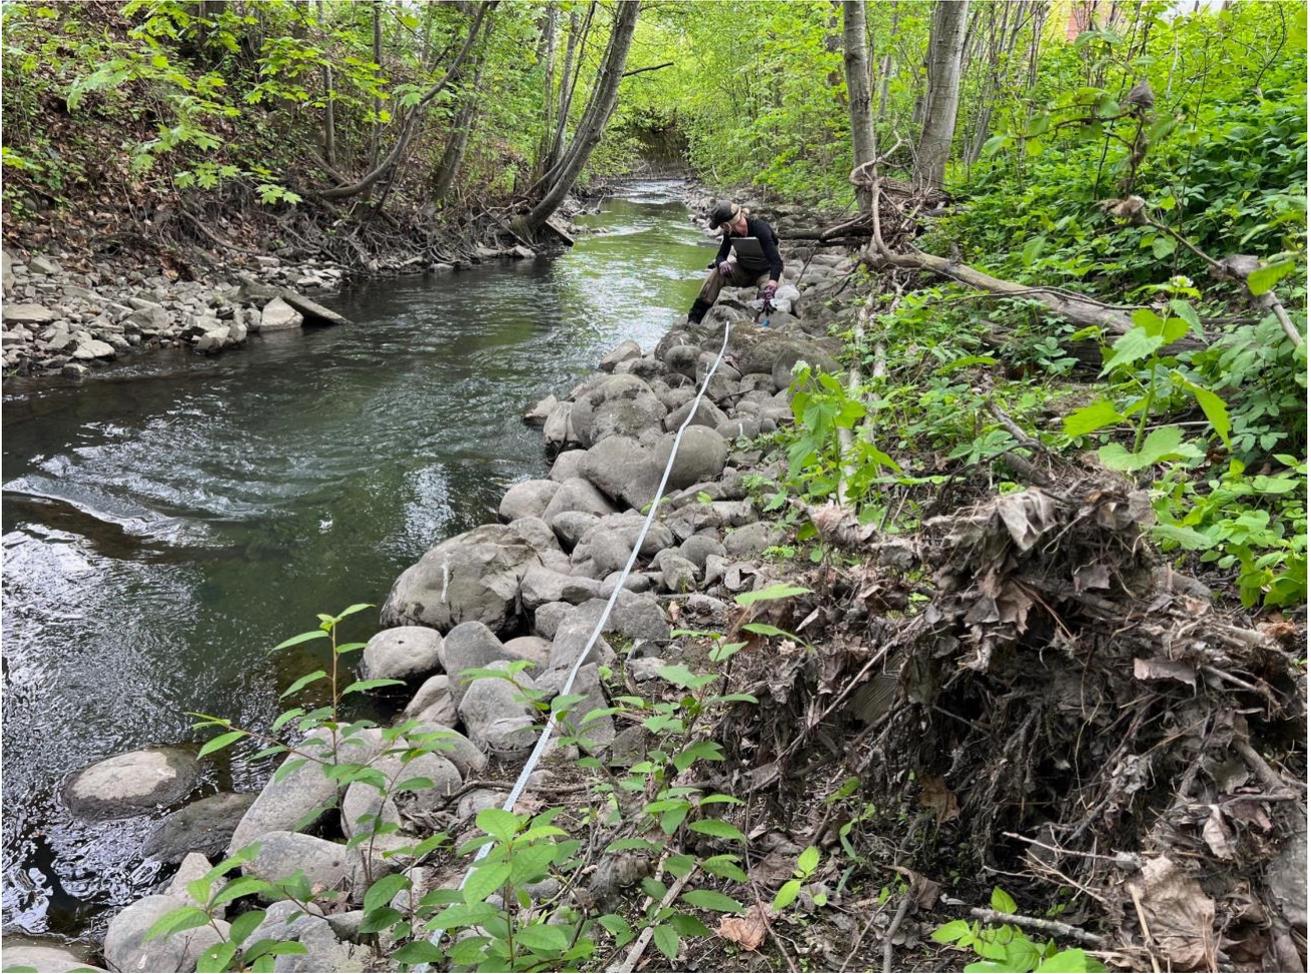
Figure 13: Photos of the urban river segment Alna B, a rather undisturbed stretch of the river running between a residential area and the train-tracks.

The Alna River segment B started outside a culvert where the river exits from underneath traffic, running behind a residential area for about a kilometre (Figure 11 and 13). There might be grates in the culverts upstream of this segment, which needs to be validated. The segment is otherwise easy to travel and clean and has boulders that may trap litter between the rocks and in the vegetation on the riverbank (Figure 12). 100 metres of rather undisturbed riverbank for monitoring in an urban area can thus be found here. The riverbank is high, and the river is not very likely to overflow. We observed 103 items and 4.9 kilos of litter in segment B (Table 2). As such this segment is suitable for monitoring. The amount of annual littering, and previous cleanup activities are unknown.

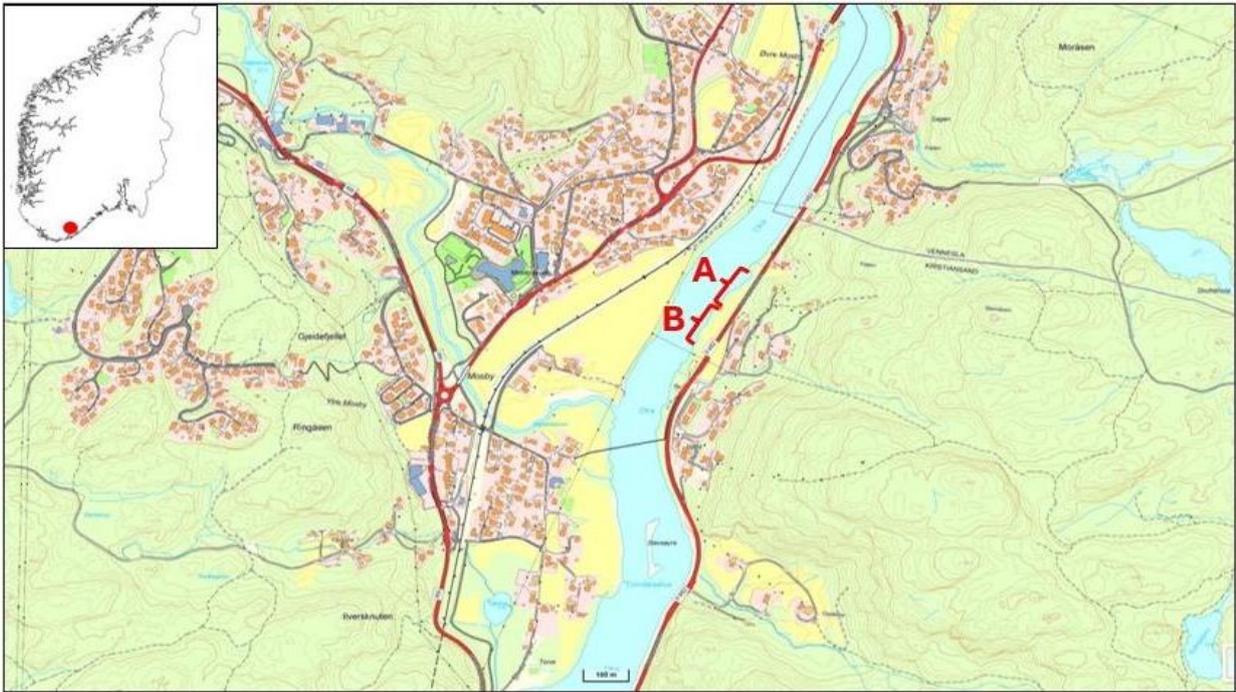
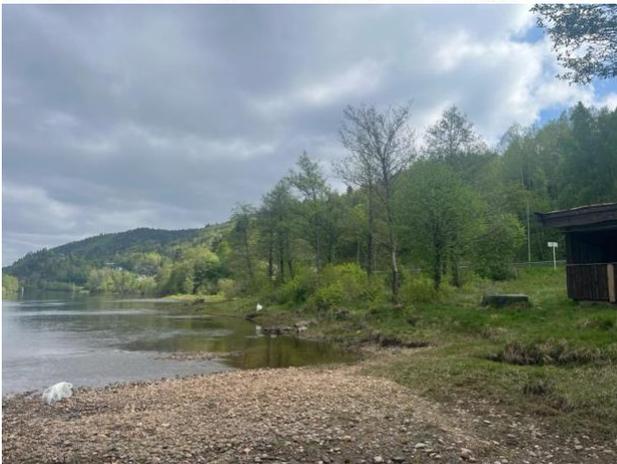
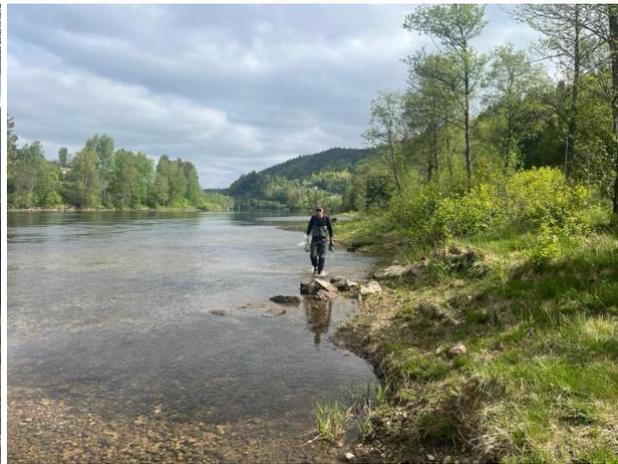
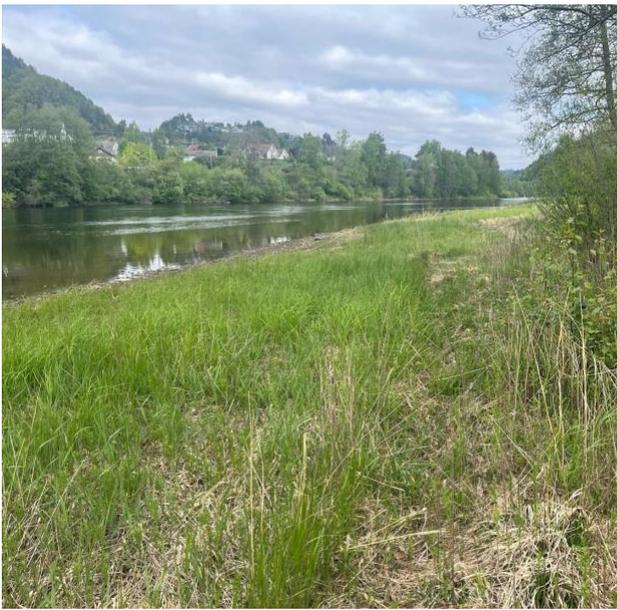
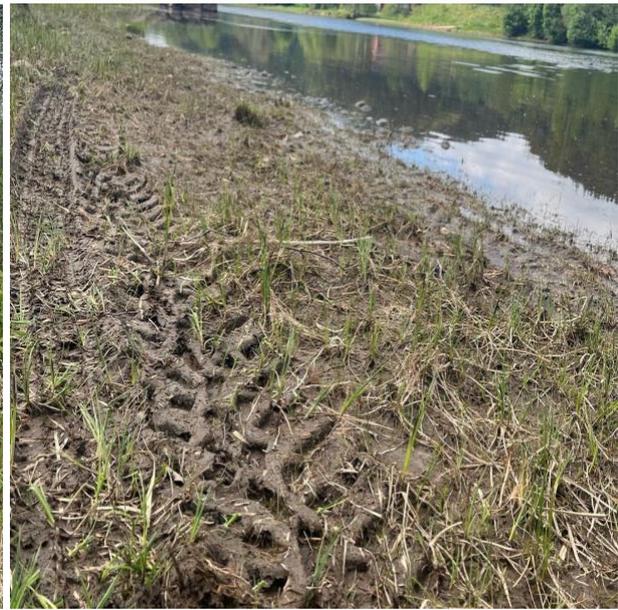
Figure 14: Map over Oтра with the two segments A and B (top), segment A (middle) with a fishing hut and segment B (bottom) with a wider riverbank and tyre tracks along the riverbank (bottom right) indicating launching of boats or jet-skis.

On the day of the survey in May, the discharge relatively low (100 m³/sec 5 km upstream at Heisel), but a mark from higher water levels could be seen on the riverbank in segment B, indicating the necessary width of the monitoring segment to include all potentially deposited debris and litter. Segment B had a wider riverbank than segment A, more grass cover and with less shrubs (Figure 14 bottom), which will impact deposition of litter.

Also, tyre-tracks on the riverbank in segment B indicated that boats or jet skis had been launched by use of motorized vehicles. Such use of the river may increase the chance of littering from recreational use but may also lead to a risk of cleaning of the segment outside of surveys. We advise finding similar and accessible segments for monitoring, that are not affected by sports and recreation such as fishing, camping or launching of jet skis and boats.

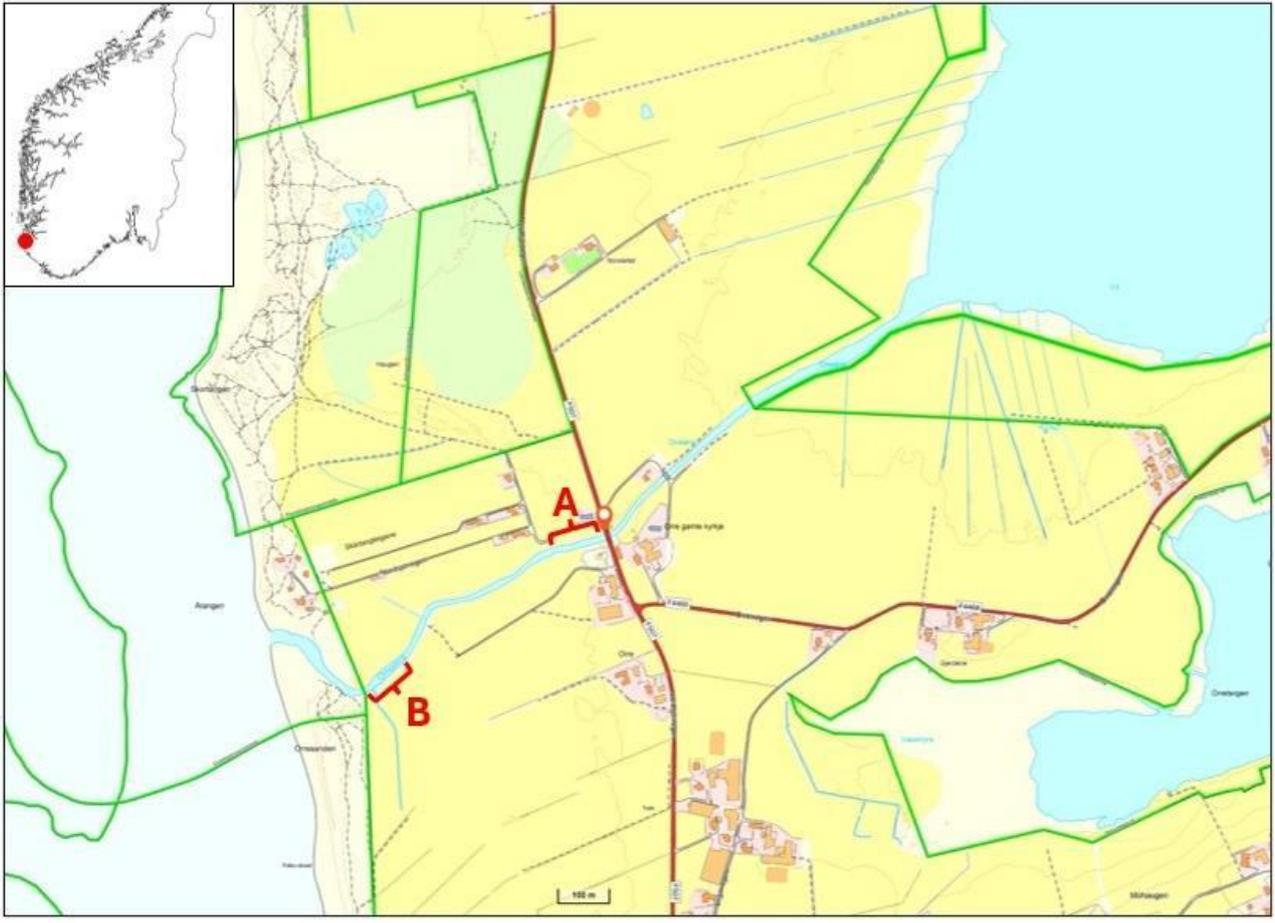
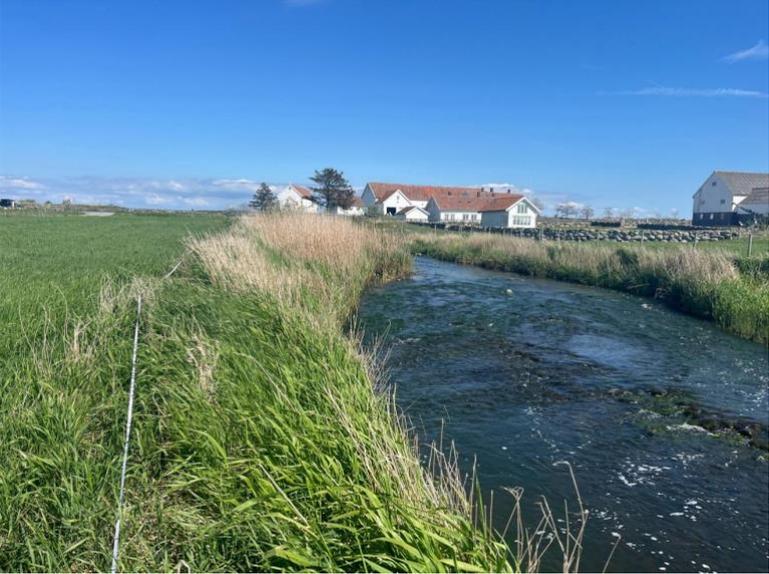
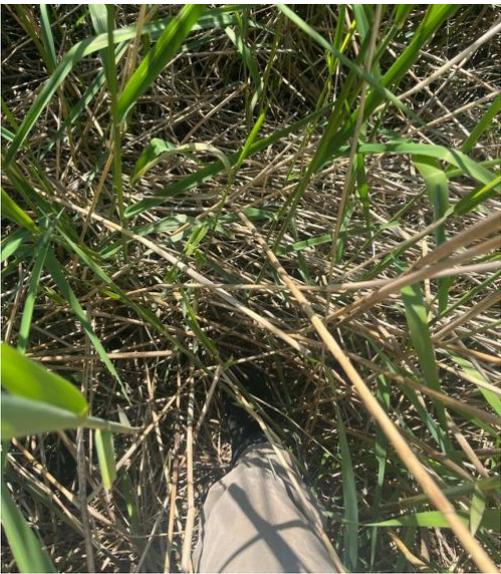
Figure 17: Map of Orre River Segments A and B (top). Photos of Orre River segment A (bottom) with dense reeds along the riverbank, potentially hiding litter. May 2025.

The shifting sand dunes cover and uncover litter over the course of a year. We observed a few litter items that may have been deposited by the river, such as bottlecaps and lids and small pieces of rope and rubber belts. However, at the start of the river segment over 100 meters upstream from the ocean we found several pieces of net-cuttings that are undoubtedly of marine origin. This indicates that the bottlecaps may also have come from the sea, as bottle caps and lids are frequently found along the Norwegian coastline (Haave et al, 2025). Strong winter storms and winds may transport marine litter up the river, and this may affect the litter types and numbers in the monitoring area. For that reason, the location does not seem suitable for monitoring of riverine litter.

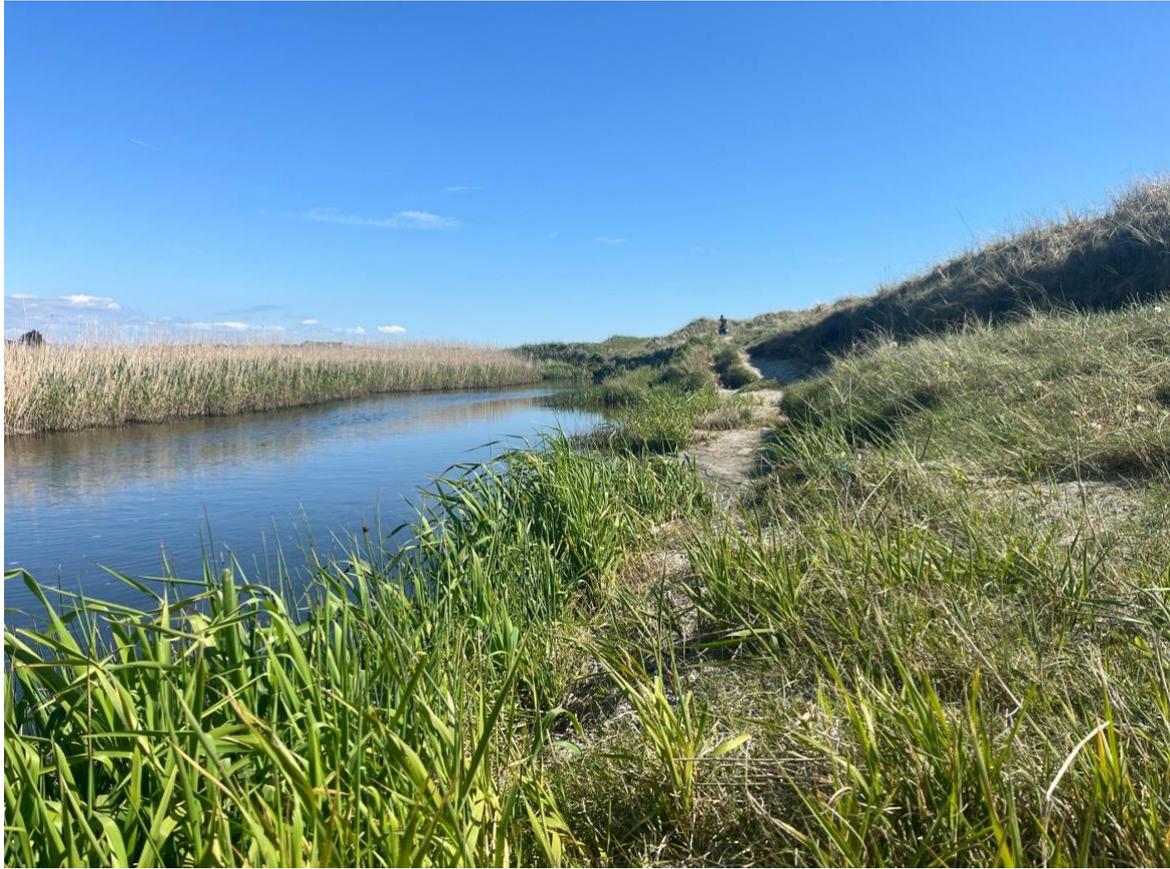
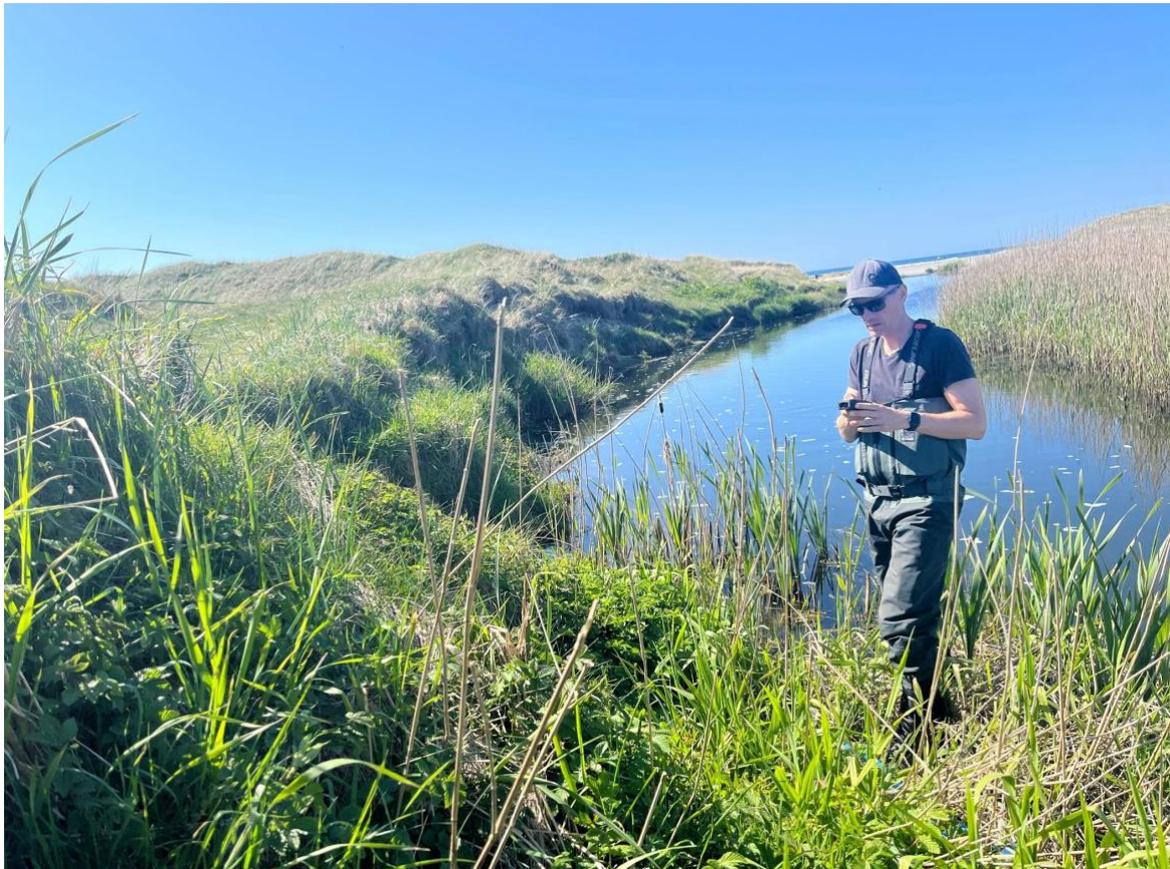
Figure 18: Orre River Segment B near the outlet at the sandy Orre beach, in May 2025. Bottom: Using the nIR tool for measuring the width of the riverbank.

The riverbank was dominated by sand, and the slopes were of variable inclination and some places steep. The discharge was normal to low and the water speed slow at the day of the survey. Segment B was monitored from land.
