**Adapting a Riverine
Litter Indicator for
OSPAR Monitoring: A
Framework for
Norwegian Conditions
M-3080|2025.**

SALT RAPPORT 1098

Miljødirektoratet/ Norwegian Environment Agency

Marte Haave (SALT) and Gaute Velle (NORCE)

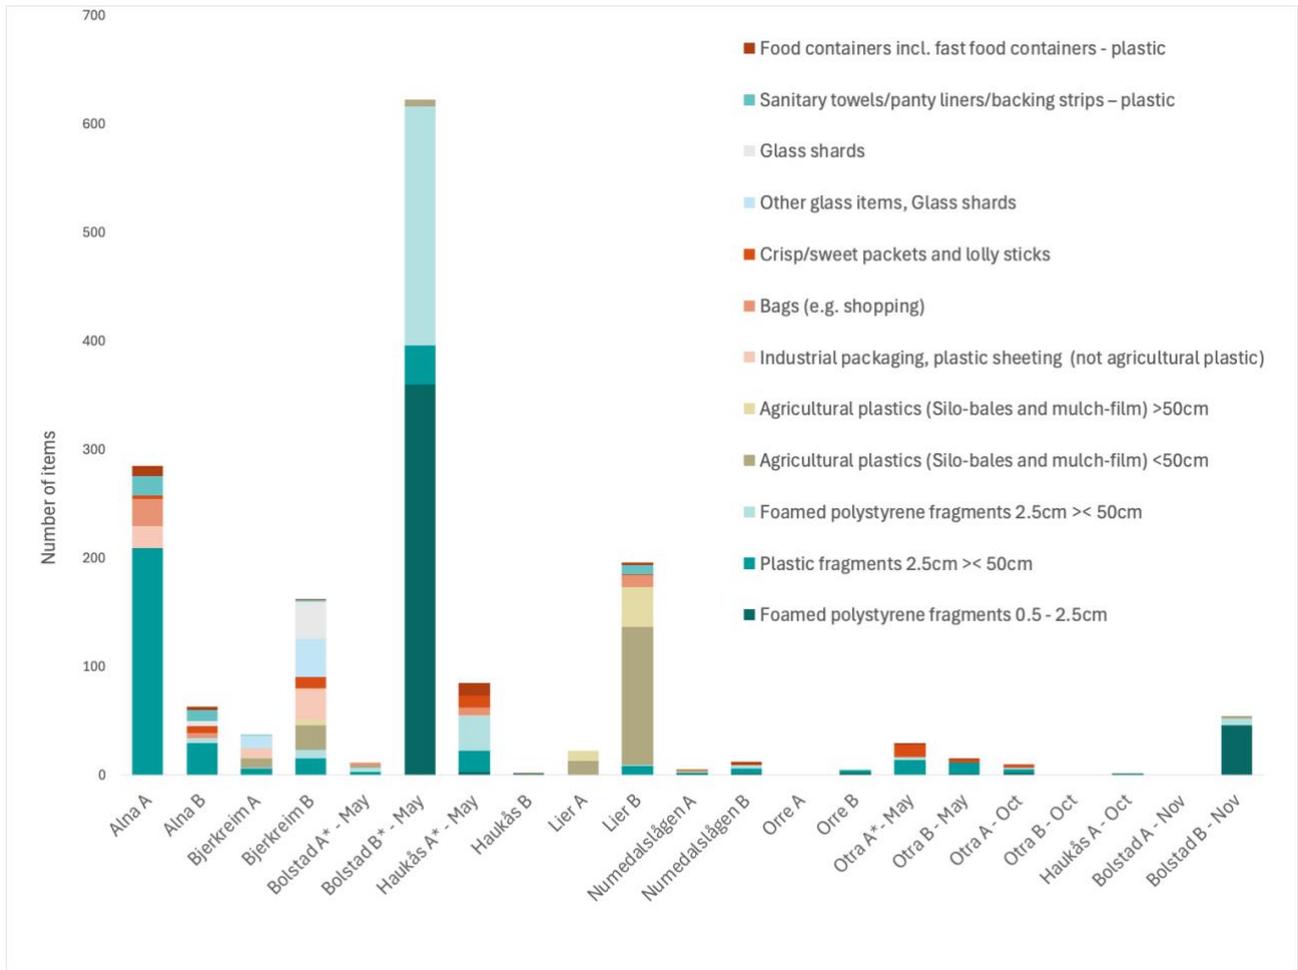
Figure 19: in October-November 2025. (Only top twelve items are shown. For the full registration of items, please see Appendix 2).

The properties of the riverbank, the substrate and hydromorphology varied within a river, as well as between rivers. The properties of each river are described in Table 1. Table 2 and Figure 19 illustrate that there are large differences in litter amounts and composition among and within a river, and that the upstream segment in the river (A) may have more litter than the downstream segment (B). We observed between 1 and 679 items per segment (Table 2, Appendix 2). Even in rivers with a high number of items per segment, such as Bolstad, Alna, Lier and Haukås, the items in the segments were markedly different. Even segments that were close together, such as segments A and B in Haukås, Bolstad and Otra, were highly different in number of litter items and composition. The segments A and B in Otra were placed adjacent to one another, and in Bolstad River they were within a short distance apart, yet there are marked differences in numbers, types and weight of the collected litter among the segments within the same river (Table 2, Figure 19 and Appendix 2). This underlines the importance of careful selection of the survey area and indicates that perhaps a higher number or longer segments should be selected for each river to provide a representative picture of the litter amounts and sources in each river.
